A study of the effect of jointing on the blasting of granite, Graniteville, Missouri

A STUDY OF THE EFFECT OF JOINTING ON THE BLASTING
OF GRANITE
GRANITEVILLE, MISSOURI

A
THESIS
submitted to the faculty of the
SCHOOL OF MINES AND METALLURGY OF THE UNIVERSITY OF
MISSOURI
in partial fulfillment of the work required for the
Degree of
MASTER OF SCIENCE, MINING ENGINEERING,
MINING GEOLOGY OPTION
Rolla, Missouri
1952

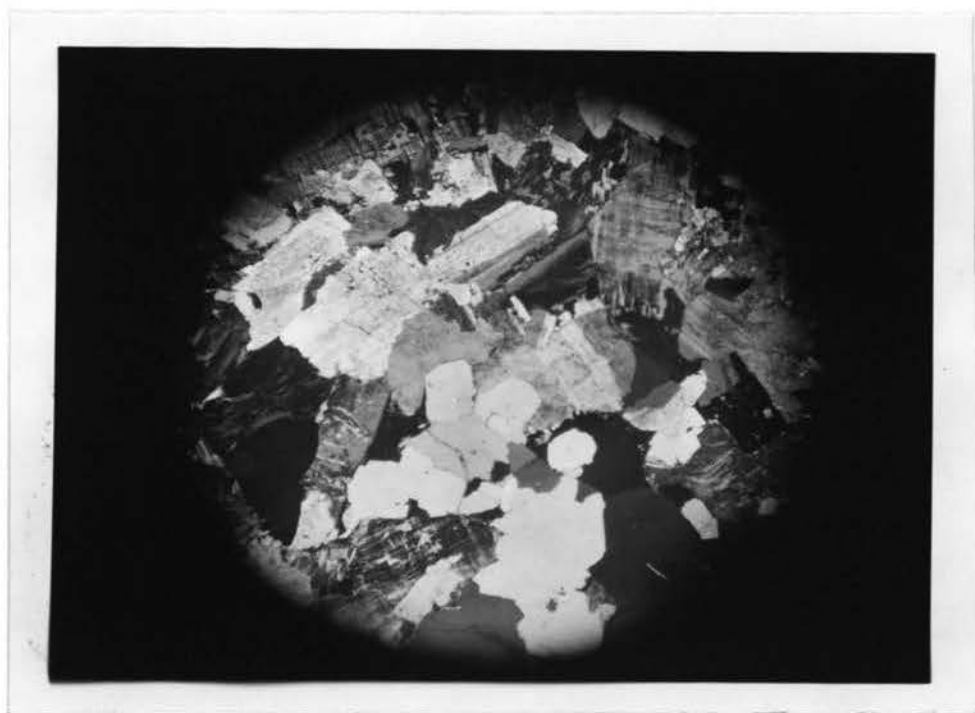
FIGURE 1

Photomicrograph of Granite

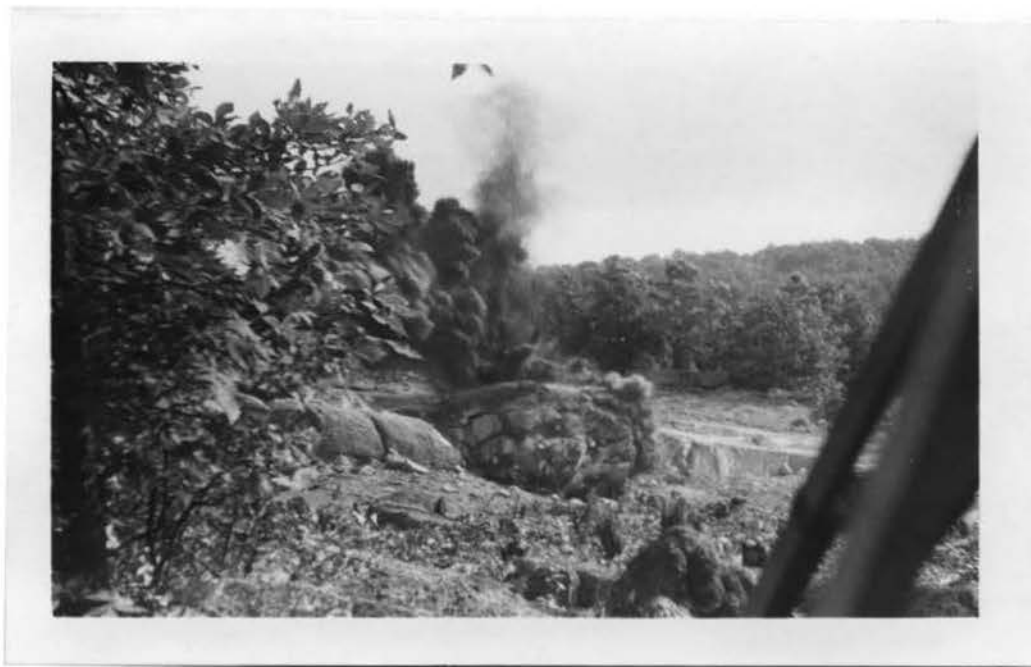
FIGURE 6

A typical round as fired at Graniteville.
Note the blocky character of the material in
the round.

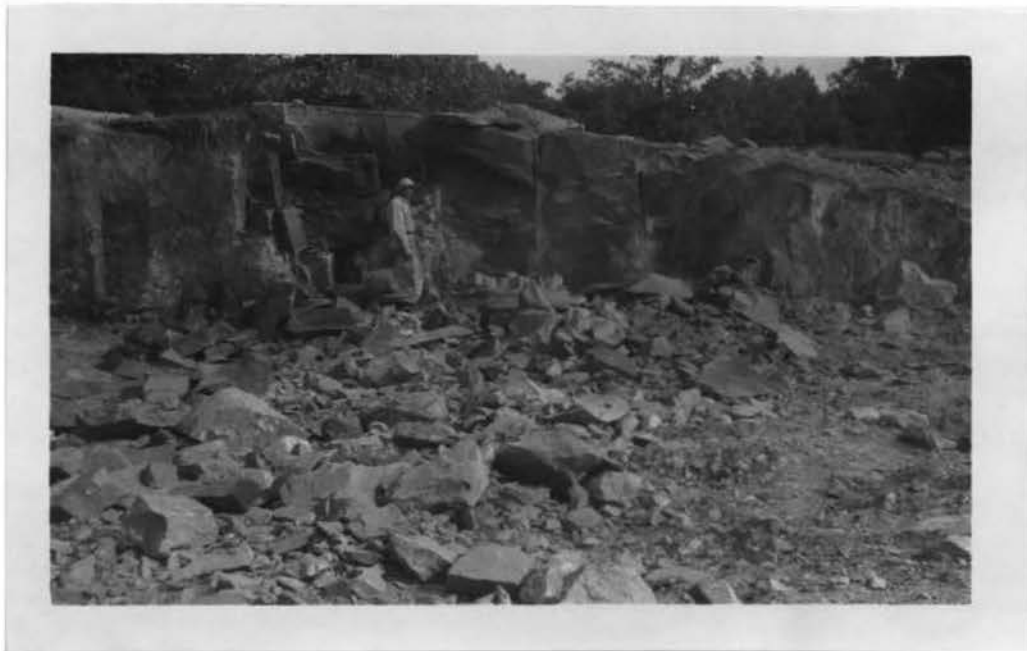
FIGURE 18

East face after Round G-11. Note that the top of the right hole is cut off. The guilty fracture can be traced from the center hole across the outline of the remaining hole.

off by the earlier firing of the center hole. An induced sheeting fracture was found in the correct position to have allowed the movement necessary to cut off the hole. As the total fragmentation was good it is thought that the rest of the charge in the west hole exploded with a high order of detonation. The round broke to the longitudinal joint and downward to a major sheeting joint (10.9 feet). The east wing formed an angle of 48 degrees with the longitudinal joint that had bounded Round G-10. Hardway fractures were developed in and around the drill holes by the blast. The vertical and curved fractures in the right portion of FIGURE 17 were induced by square-up blasting.

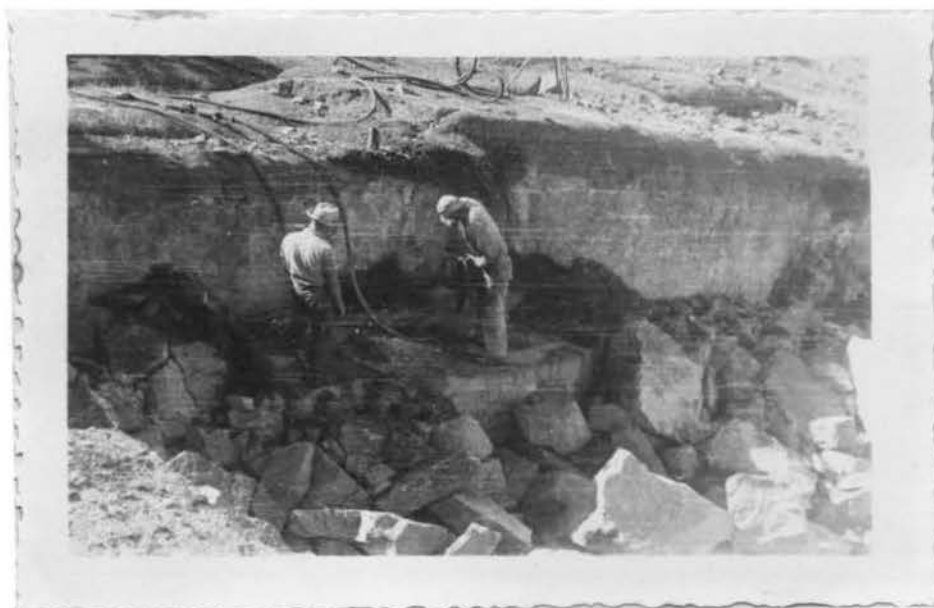
FIGURE 20

Preparing the slab, produced by
Round G-13, for secondary
blasting.
